Manhole Inspection Summary

Manhole # S35KK1011MH

Insp Date: **3/12/07 10:58 AM**

Location Address: **4311 UNDERWOOD RD**

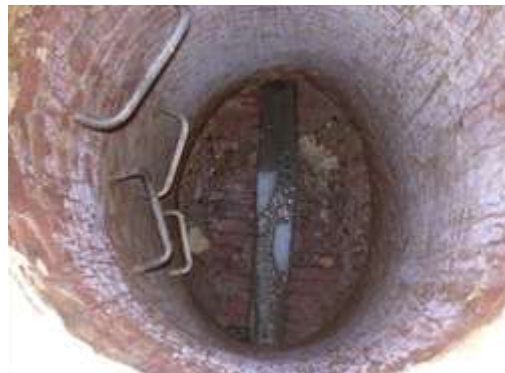
Top View

Evidence of surcharge - Bench debris.
Channel debris.

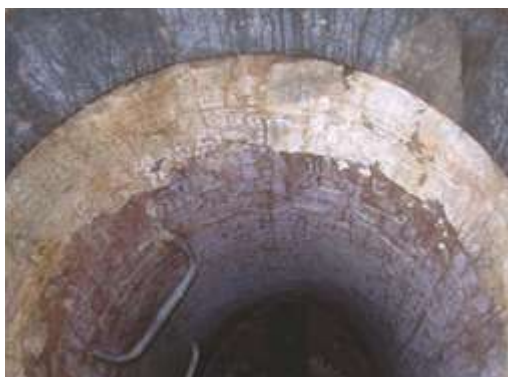
Defect

Infiltration: ☐ None ☒ **Joint** ☐ Cracks ☐ Mortar ☐ Roots ☒ **Wall**

Infiltration: ☐ None ☐ Joint ☐ Cracks ☐ Mortar ☐ Roots ☒ **Wall**

Adjustment and Barrel infiltration.

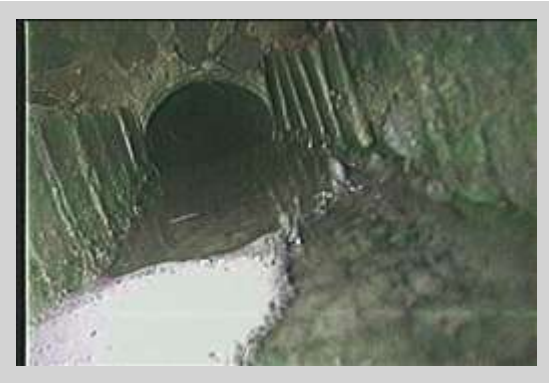
6 in. Circular Gravity Sewer Pipe Out @ 12 O'Clock

Channel deterioration.

Infiltration: **Evidence** Pipe Seal Cond: **Cracked**

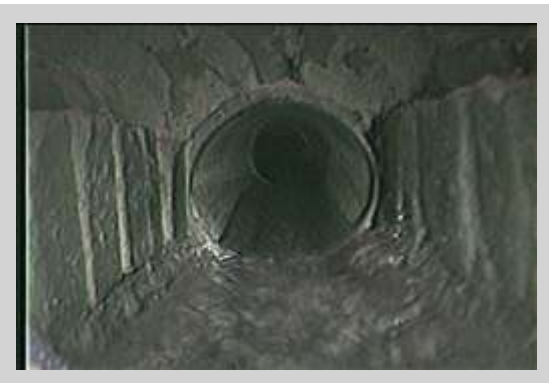
8 in. Circular Gravity Sewer Pipe In @ 6 O'Clock

Infiltration: **Evidence** Pipe Seal Cond: **Cracked**
